# Service Campaign Bulletin

Campaign No. 2007010001, February 2007

SUBJECT: **MODELS 164, 209, 211, 219, 251 AMG**  
**MODEL YEAR 2007**  
**REPLACE POLY V-BELT AND TENSIONER (M156 ENGINE)**

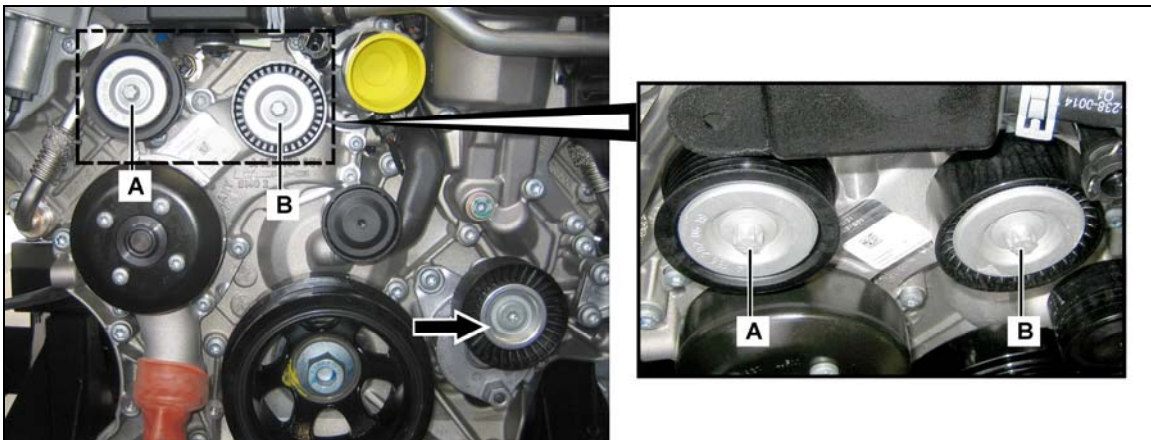
**Figure 1**

This Service Campaign has been initiated because DCAG has determined that on affected vehicles (see VIN range on the following page) the poly V-belt tensioner may emit noise. Dealers will replace the poly V-Belt and tensioner and check for the proper installation of the belt guide pulleys.

1. Open engine hood.
2. Remove poly-V-belt.
3. Replace poly-V-belt tensioner (arrow, Figure 1); refer to one of the following WIS documents, depending on vehicle model:
  - Model 164/251: AR13.25-P-3200GZS
  - Model 209/211/219: AR13.25-P-3200TMG

4. Check installation positions of guide pulleys A (grooved) and B (smooth).
  - If pulleys are not installed in positions shown in Figure 1, install pulleys in correct positions; torque bolts to 20 Nm.
  - If pulleys are installed as shown in Figure 1, proceed to next step.
5. Install new poly-V-belt.
6. Close engine hood.
