Campaign No. 2006060003, June 2006

SUBJECT: **MODEL 199, MODEL YEAR 2005-2006**  
**REPLACE ALTERNATOR AND CL CONTROL MODULE; INSTALL HEAT SHIELD ON**  
**NEW ALTERNATOR**

**Safety Recall #2006060003**

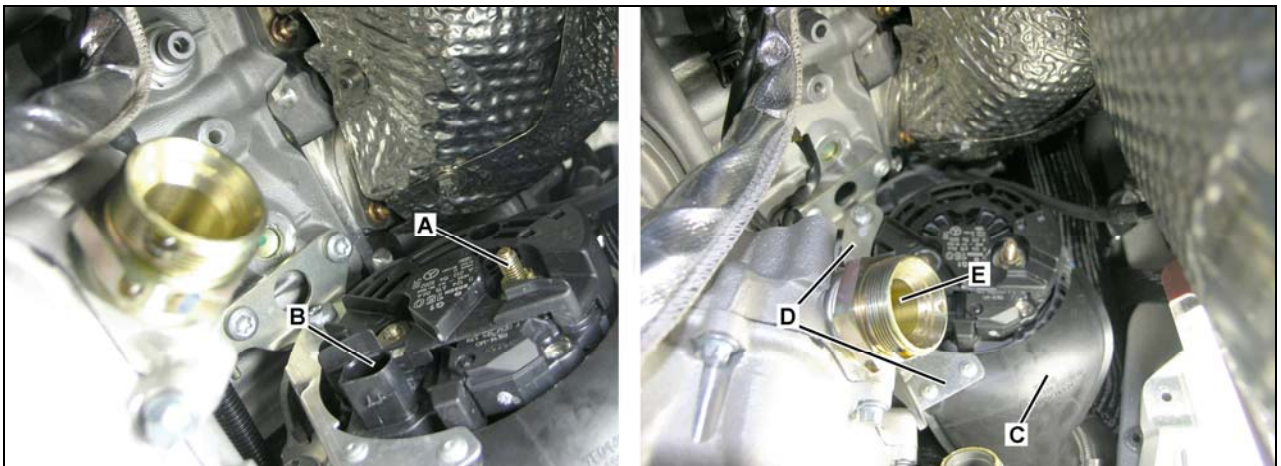
**Figure 1**

- Remove B+ connector cap and nut (A, Figure 1).
- Remove connector coupling from alternator (B)

- Remove air duct (C) and bracket (D) from alternator.
- Remove front alternator mounting bolts.
- Remove oil return line adapter (E) from upper oil pan.

- Connect line B+ to alternator (A, Figure 1); torque bolt to 15 Nm.

5. Reassemble in reverse order.
- Torque oil return line adapter (E, Figure 1) at upper oil pan to 60 Nm.

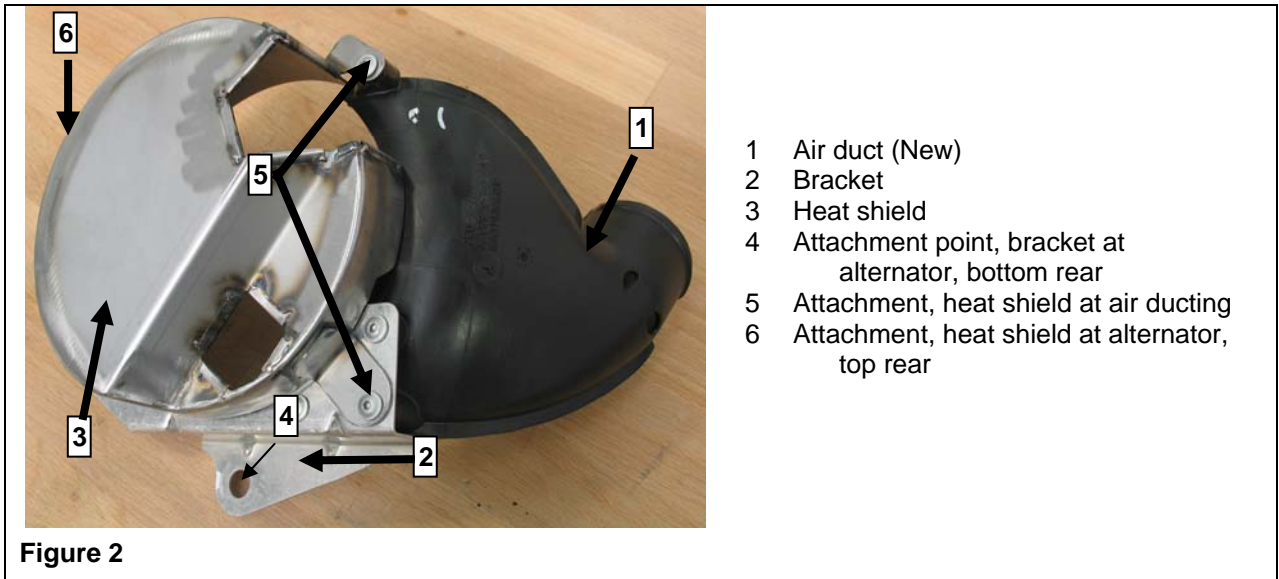
- 1 Air duct (New)
- 2 Bracket
- 3 Heat shield
- 4 Attachment point, bracket at alternator, bottom rear
- 5 Attachment, heat shield at air ducting
- 6 Attachment, heat shield at alternator, top rear

4. Install new alternator and new air duct (1, Figure 2).

**Reuse the existing bracket (2) between the heat shield and alternator. Do not reuse the existing air duct.**

- Install new alternator and tighten front mounting bolts. Torque bolts to 30 Nm.
- Fasten new air duct (1) with bracket (2) for heat shield (3) to lower rear mounting for alternator.

- Affix heat shield to top rear (6) of alternator.
- Fasten heat shield to air duct (5).

**Reuse one existing bracket screw and use the one new screw provided to fasten the heat shield to the air ducting.**
